Manhole Inspection Summary

Manhole # S39U__043MH

Insp Date: **2/20/09 12:38 PM**

Location Address: **764 BOYLE ST**

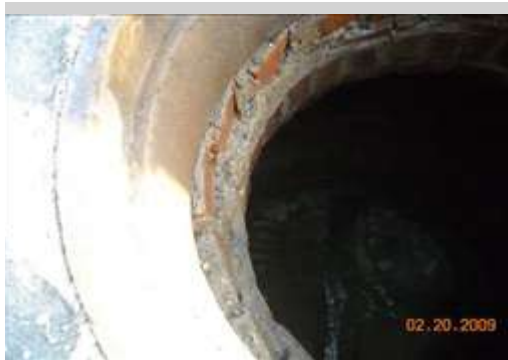
Defect 1

Offset: **2** (in.)

FRAME OFFSET

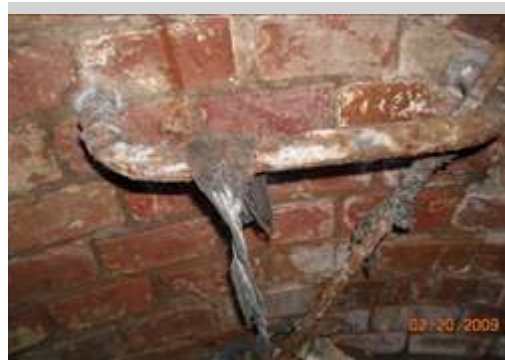
Defect 3

Count: **4** Missing: **0** ☒ **Corroded**

☒ **Evidence Of Surcharge** Depth: **4** (ft.) ☐ Active Surcharge Present

Corroded steps & EVIDENCE OF SURCHARGE

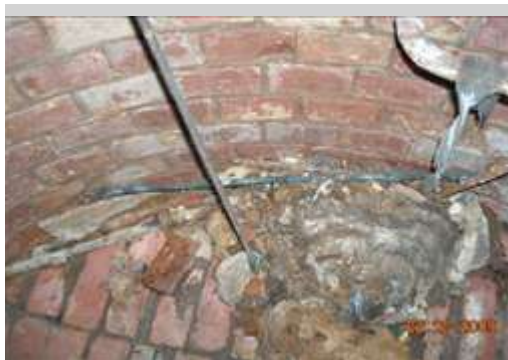
Defect 2

Condition: ☐ Sound ☐ Cracked ☐ Root Intrusion ☐ Deteriorated ☐ Leaks ☒ **Debris**

DEBRIS ON BENCH

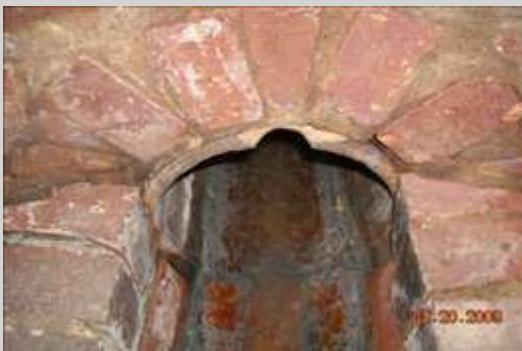
3 O'Clock Inflow

Pipe Height: **8.4** (in.) Rod and Bar (Angled)
Pipe Material: **Clay** ☐ Pipe Lined
Invert Depth: **8.40** (ft.) Flow Characteristics: **Slow**
Deposits: ☒ None ☐ Mud ☐ Sludge ☐ Debris ☐ Grease
Silt Depth: **0** (in.) Deposits Extent:
Infiltration: **None** Pipe Seal Cond: **Cracked**
